Test Debris Description and Quantification

GTP-01-02-02

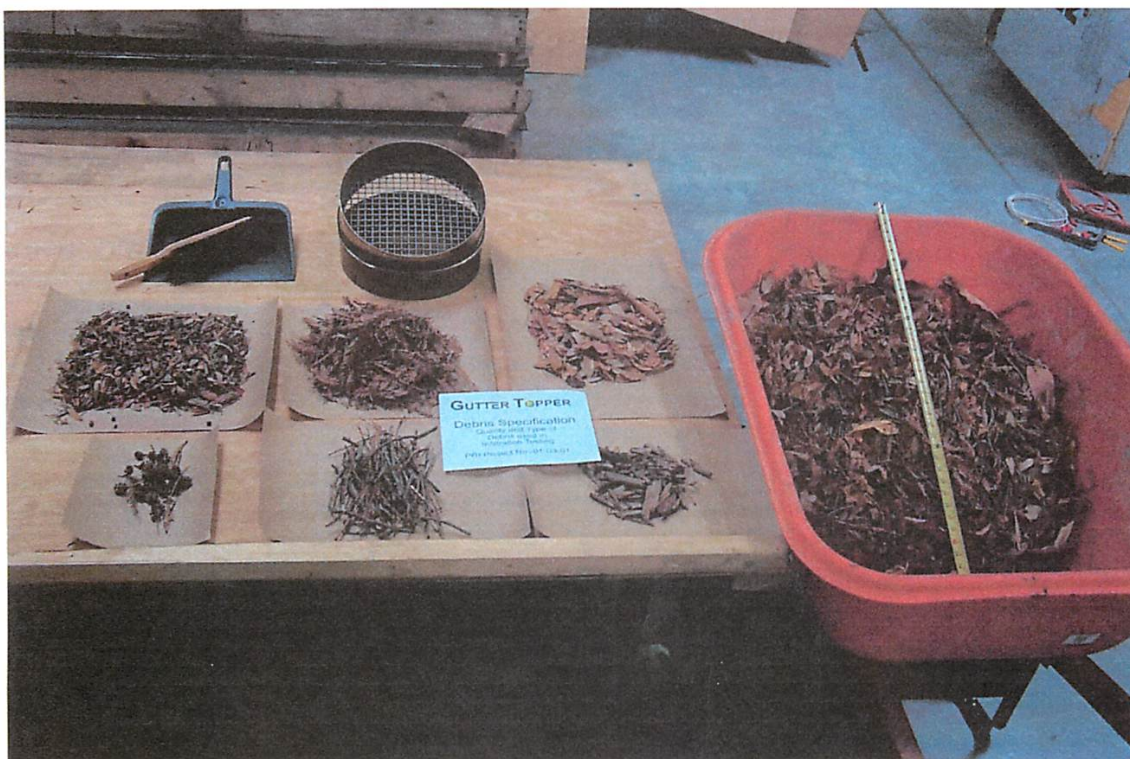
Test Debris Description and Quantification

Test Debris Quantification

Approximately ten pounds of typical roof debris was collected and hand mixed in a large wheelbarrow. A sample was removed from the mix and sieved to remove the fine debris. The material which did not pass a 1/2" sieve was sorted by type of material. The fractions were weighed and the weights recorded. The components of the debris were recombined and dried in an oven at 180°F to a constant weight to determine the moisture content.

Material	Description of size		Weight In grams	Percentage of mix
Leaves	Largest dimension between	1" and 9" inches	138.4 g	10%
Bark	Ranging in width between Ranging in length between	1/4 and 1 inch 1/4 and 4 inches	230.3 g	17%
Twigs	Ranging in diameter between Ranging in length between	1/16 and 1/2 inch 1-1/2 and 14 inches	232.7 g	17%
Pine Needles	Ranging in length between	1-1/2 and 10 inches	219.2 g	16%
Mix of leaves, bark, twigs, and pine needles.		Passing 1/2" sieve	540.2 g	40%
Debris mix moisture content		12%	Total weight 1360.8 g 3 lbs.	100%

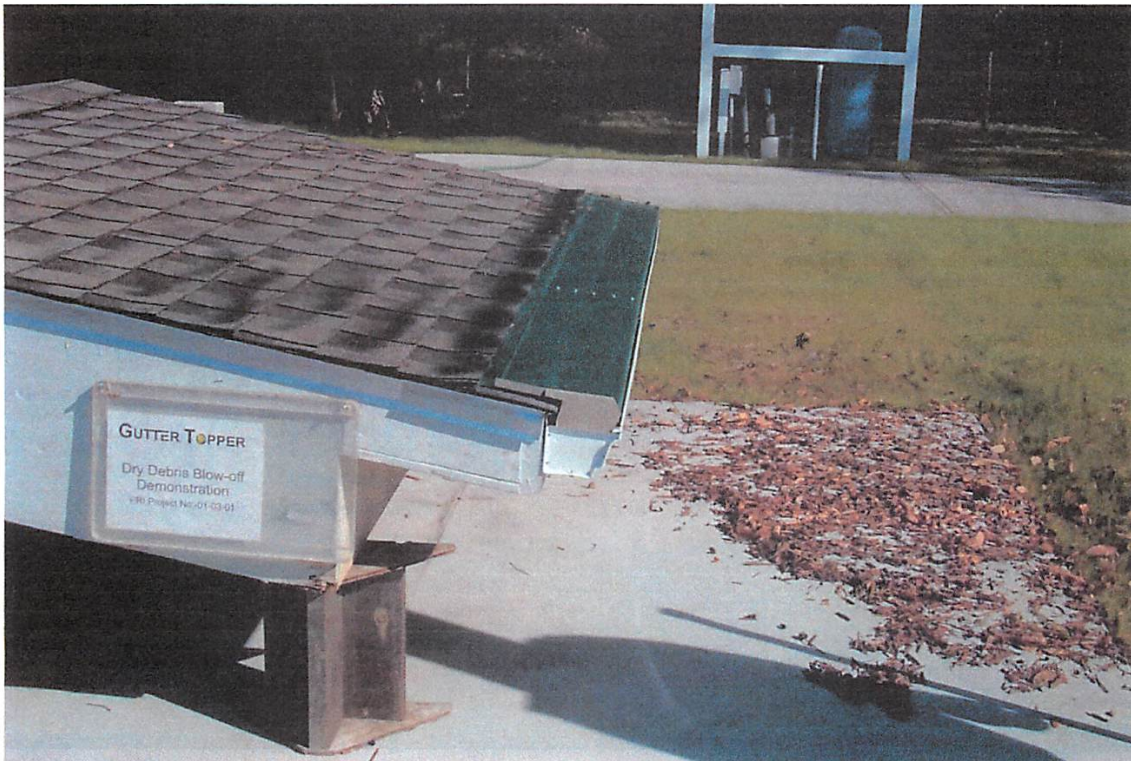
After Dry Debris Trapping Test

Three pounds of the debris mix, at 12% moisture, was uniformly applied to the test deck. Debris blow off was accomplished with the leaf blower held 12 feet from the ridge of the test deck and aimed down slope towards the gutter cover being tested. Sweep deck until debris is removed. After completing the blow off, the Gutter Topper unit was examined for debris.

Results: No debris was found in the Gutter Topper cover or in the gutter.
